March 3, 2017

Re: Former Dangman Park Manufactured Gas Plant Site
IRM Premobilization Investigation Results
Brooklyn, New York
NYSDEC Site No. 224047
Index # A2-0552-0606

IRM PREMobilIZATION INVESTIGATION

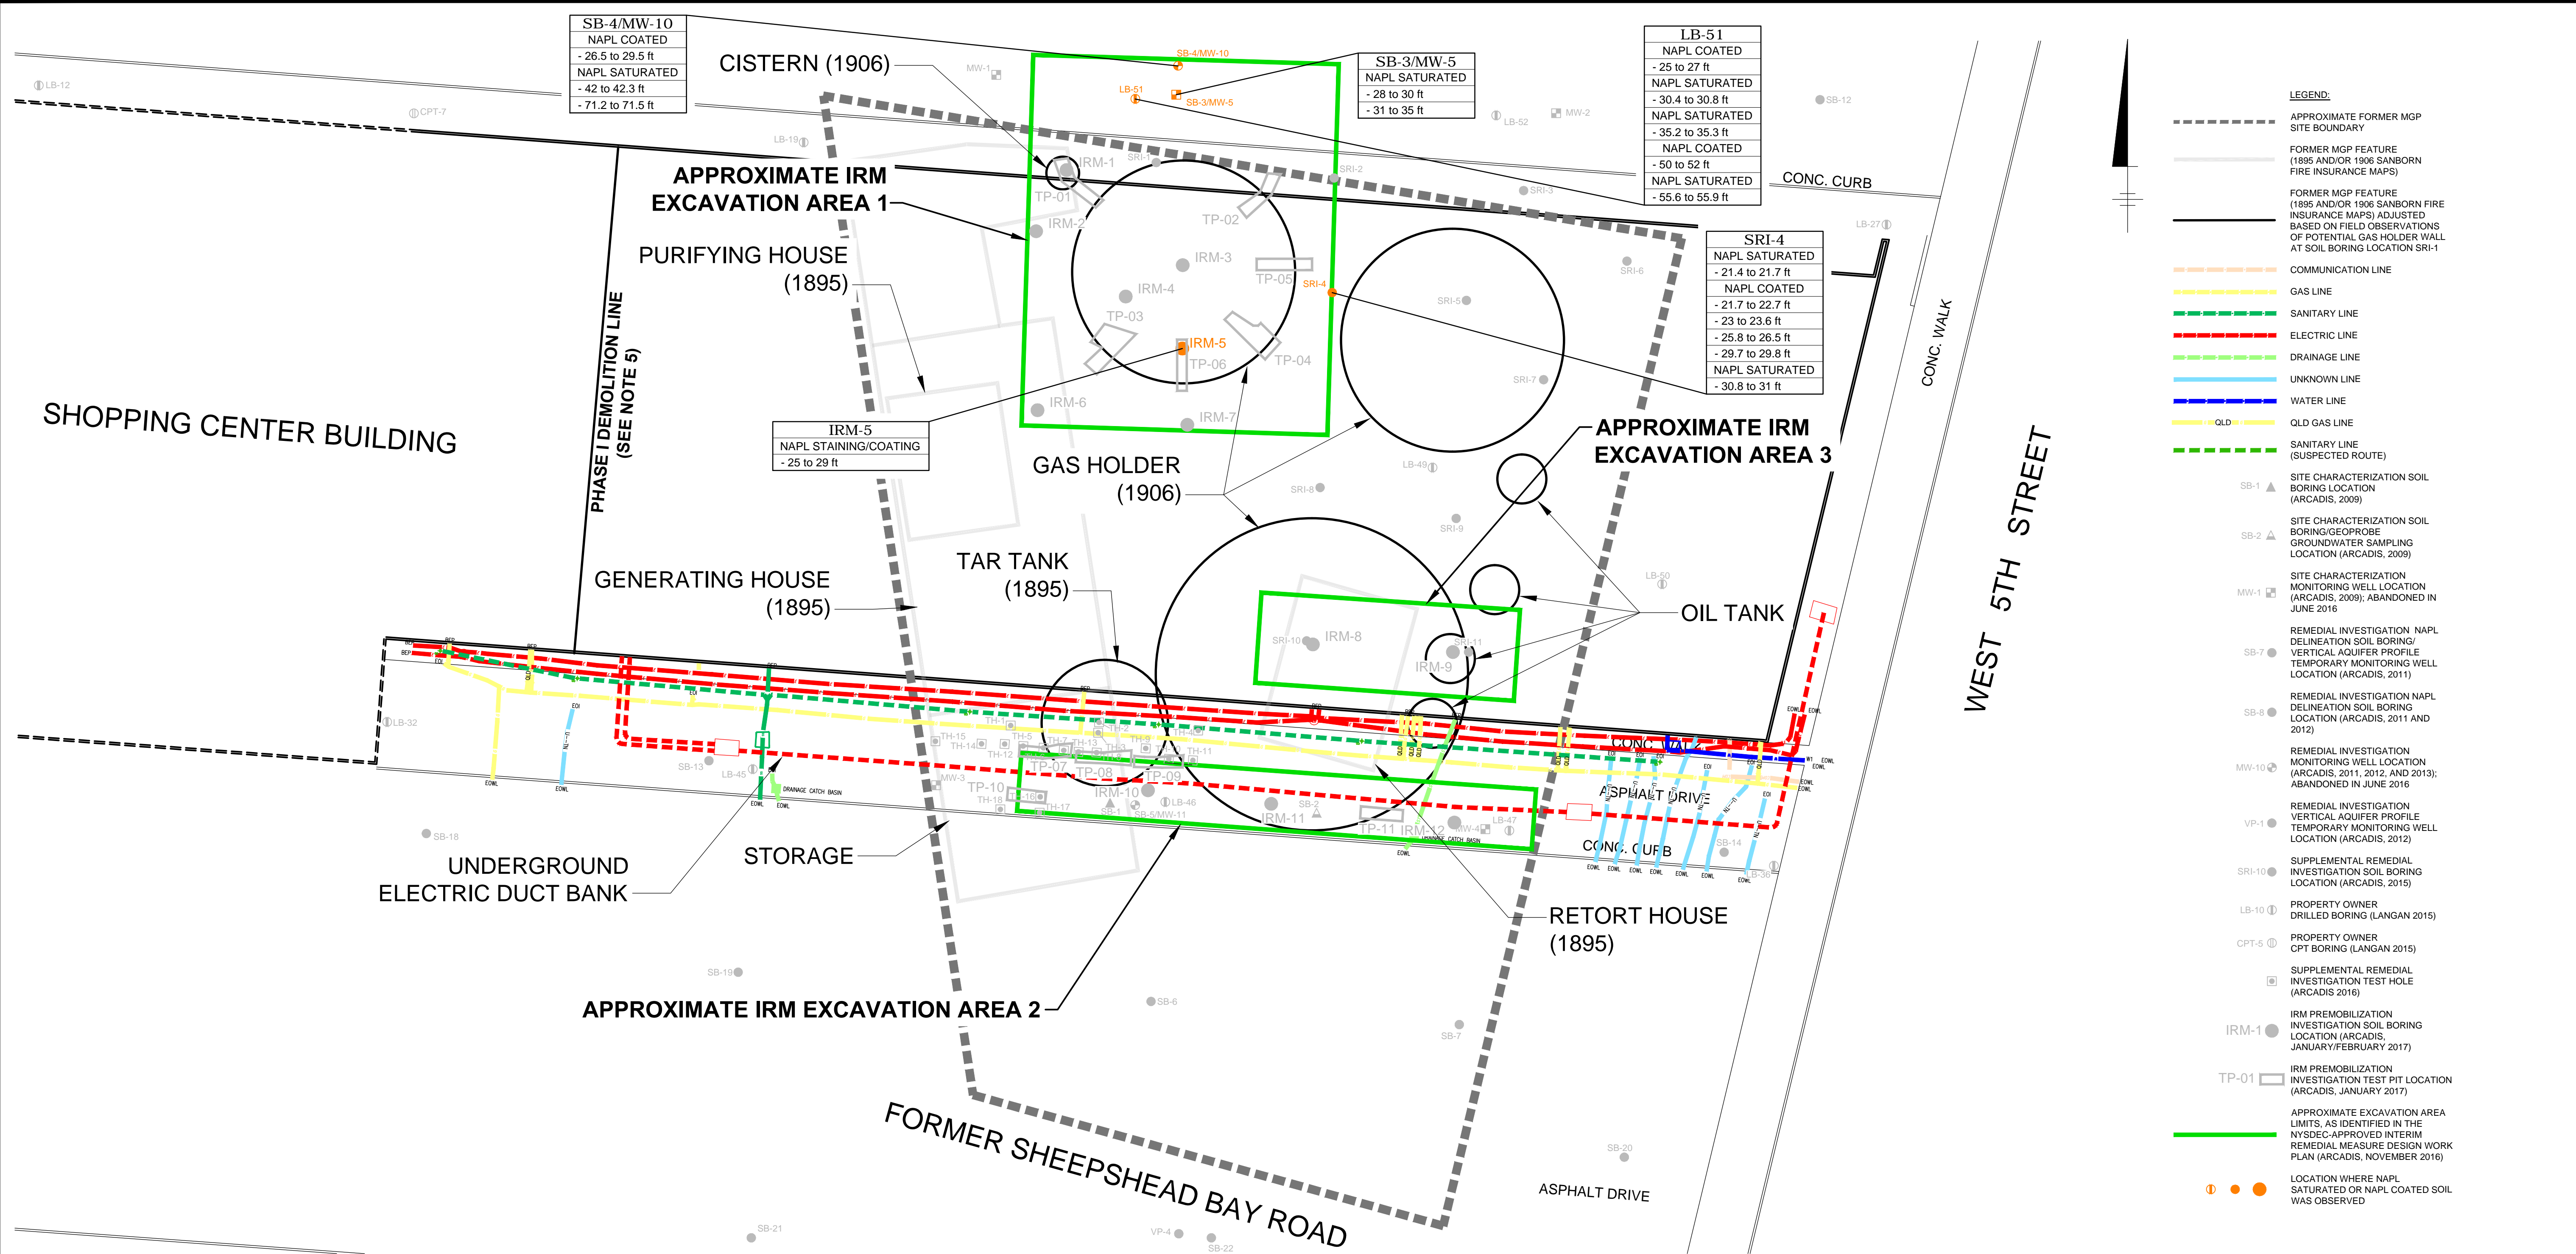
FIGURE
3

Consistent with figures presented in the NYSDEC-approved IRM Design Work Plan, all NAPL saturated or NAPL coated soil observed within IRM Excavation Area 1 are detailed on Figures 2, 3 and 4 from the water table to 15 ft bls, from 15' to 21' bls, and below 21' bls, respectively. As shown on Figure 2, NAPL saturated or coated soil was observed outside the holder walls in IRM Excavation Area 1 within the upper

15 ft at three discrete locations: LB-51 (8-12 ft saturated NAPL), SRI-2 (13.6-14 ft NAPL coated), and IRM-6 (14.5-15 ft NAPL coating). Within the 15 ft to 21 ft bls interval, NAPL was intermittently observed at three locations: LB-51, SRI-1, and SRI-4 (Figure 3); at two of these locations NAPL was not observed in the upper 15 ft. LB-51 is the only location in IRM Excavation Area 1 where NAPL saturated or coated soil was observed in both the upper 15 ft and within the 15 ft to 21 ft bls interval; however, as detailed on Figures 2 and 3 the NAPL was intermittently present at LB-51 and was not observed in the upper 21 ft at adjacent soil boring locations (SB-3, SB-4, and MW-1). LB-51 is also the only location in IRM Excavation Area 1 where NAPL was observed above 13.6 ft.

SB-4/MW-10
NAPL COATED
- 26.5 to 29.5 ft
NAPL SATURATED
- 42 to 42.3 ft
- 71.2 to 71.5 ft

SB-3/MW-5
NAPL SATURATED
- 28 to 30 ft
- 31 to 35 ft

IRM-5
NAPL STAINING/COATING
- 25 to 29 ft

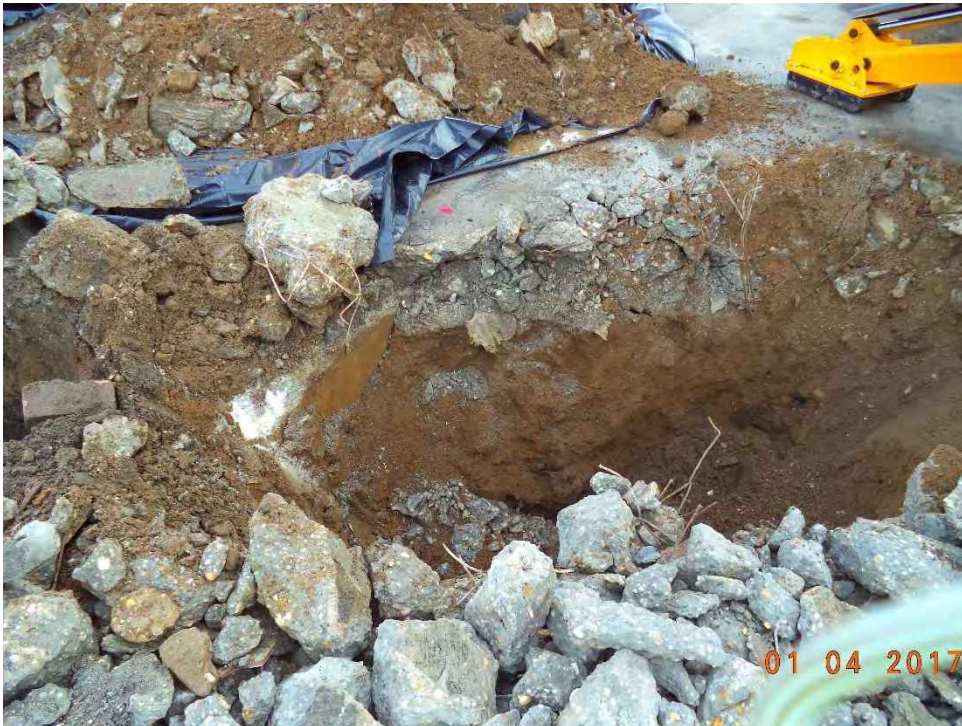
Photograph: 2

Description:
TP-01
Building Foundation
Wall

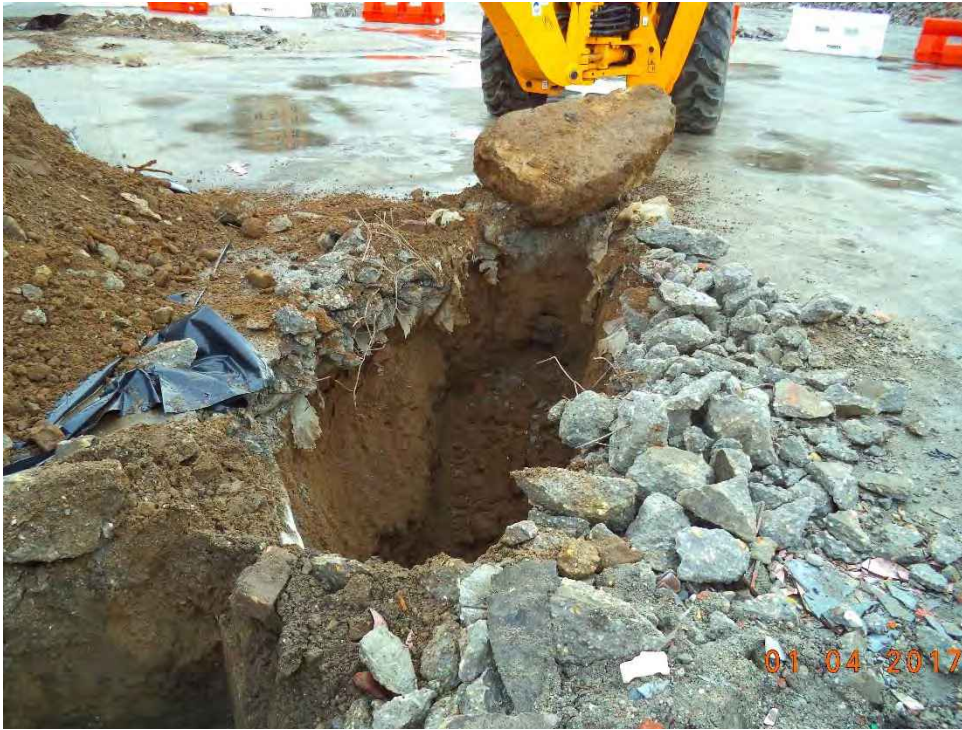
Photograph: 5

TP-01
Concrete foundation
wall

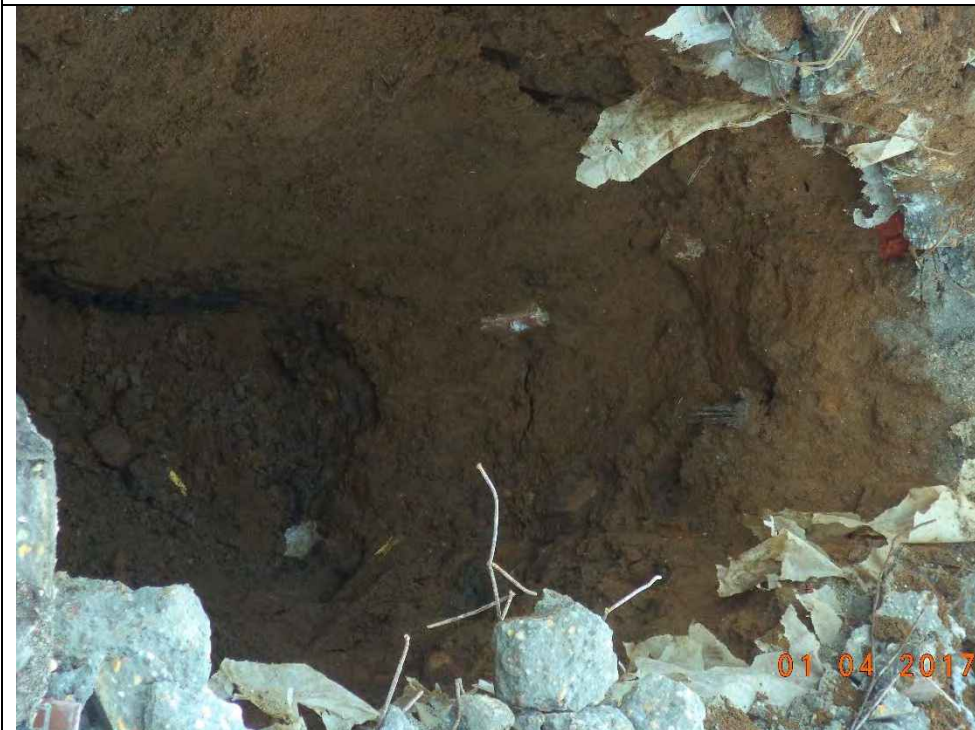
Photograph: 8

Description:
TP-01
Top of holder wall at
3.5 ft bgs

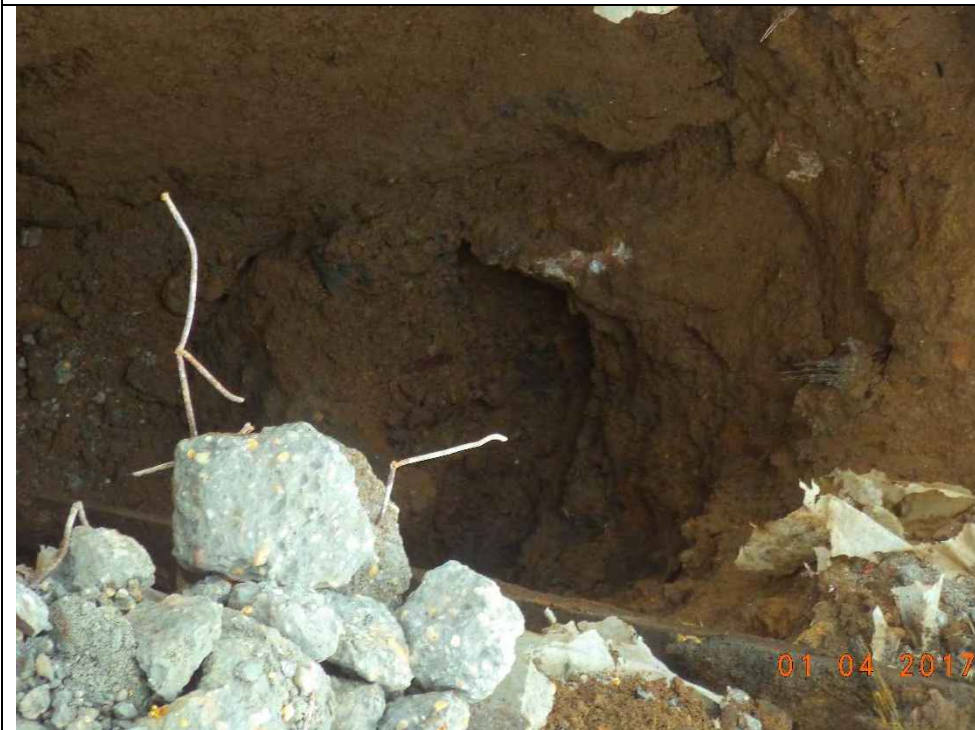
Photograph: 10

Description:
TP-01
Holder wall
components and large
steel fill

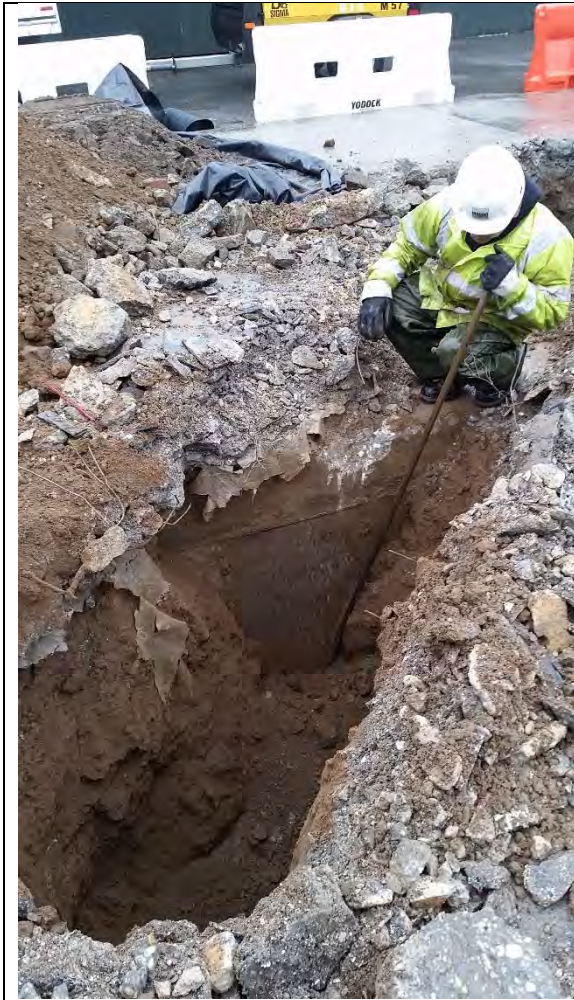
Photograph: 15

TP-02
Concrete foundation
wall

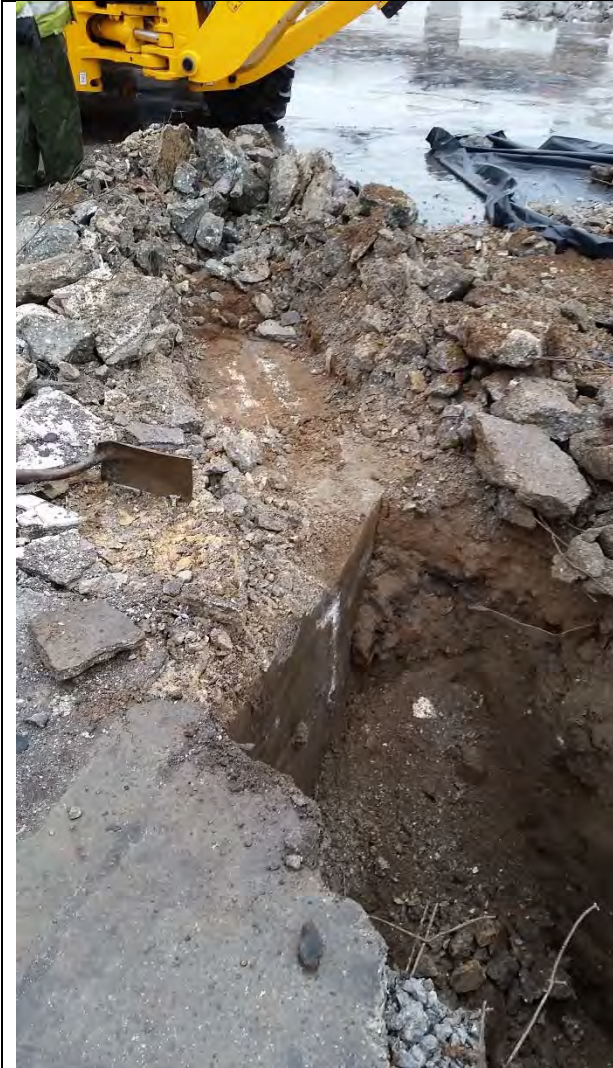
Photograph: 16

TP-02
Concrete Foundation
Wall

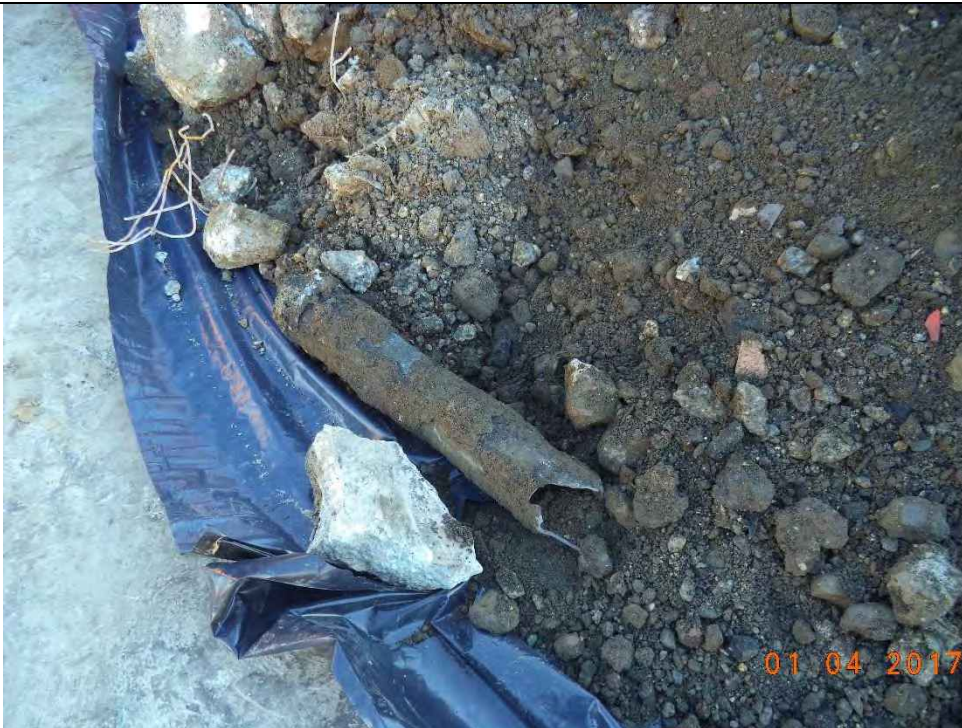
Photograph: 18

Description:
TP-03
Fill Materials:
abandoned steel pipes

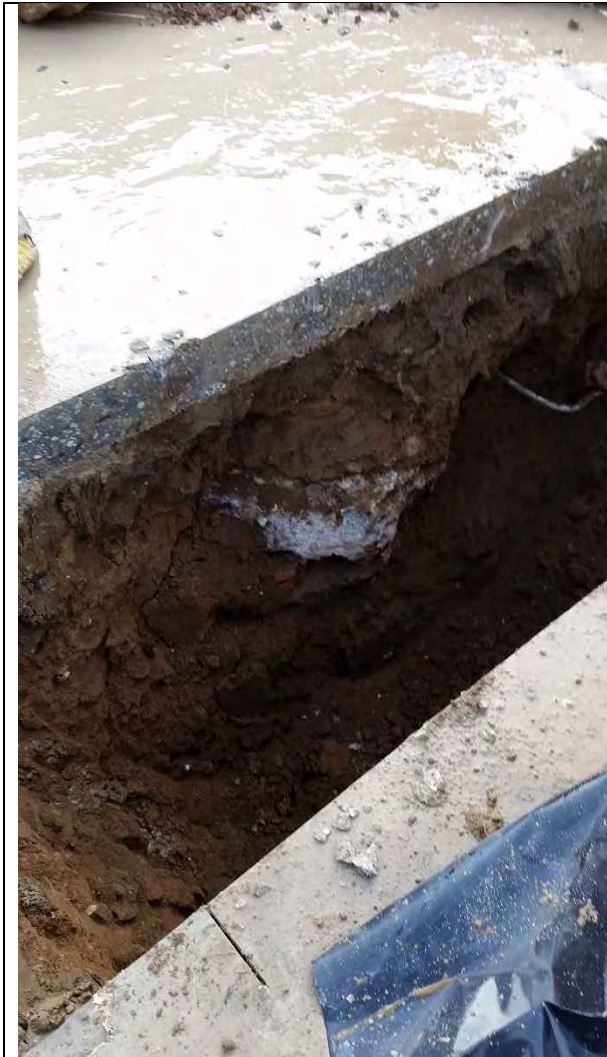
Photograph: 34

Description:
TP-05
Continuation of holder
wall

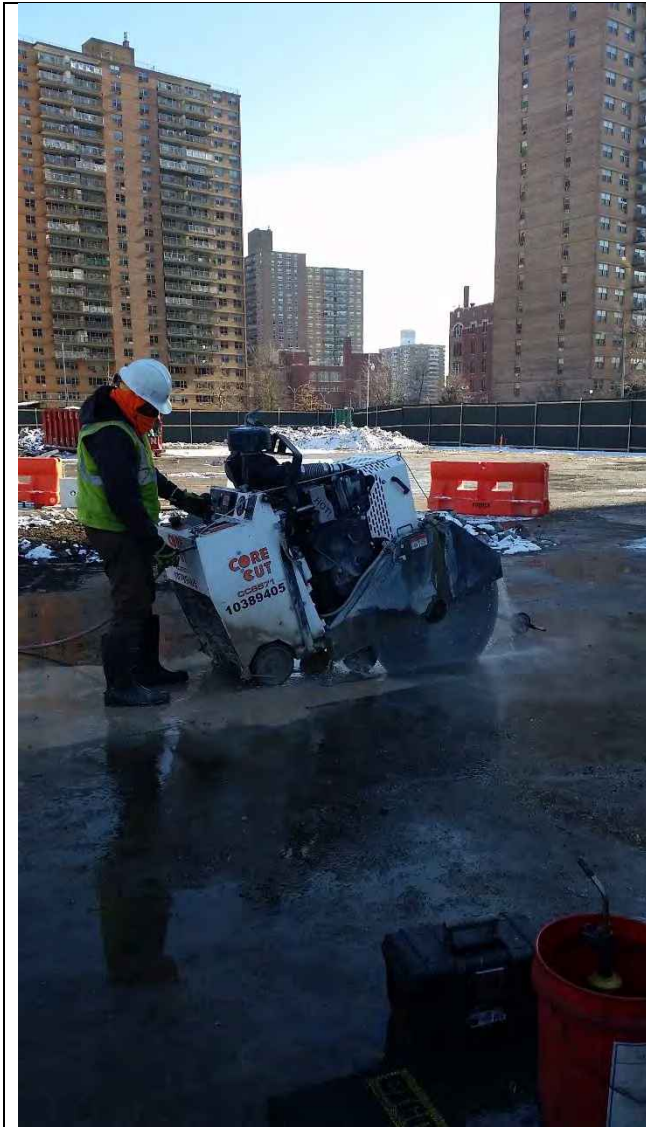
Photograph: 36

Description:
TP-06
Core Cutting Concrete
Slab

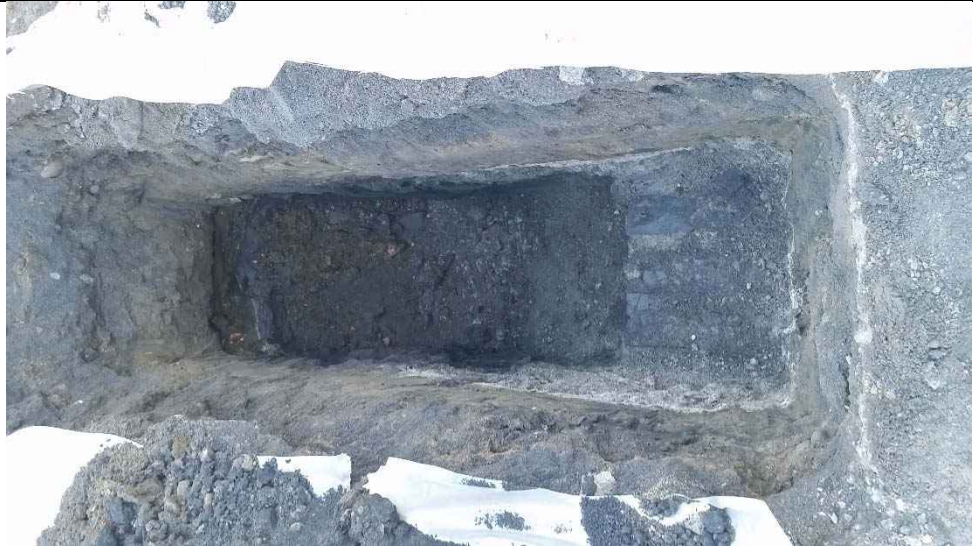
<p>Photograph: 17</p> <p>Description: TP-10 Concrete stained foundation piece on eastern and western end of TP</p> <p>Location: Brooklyn, NY</p> <p>Photograph taken by: Kyle Warren</p> <p>Date: 1/19/2017</p>

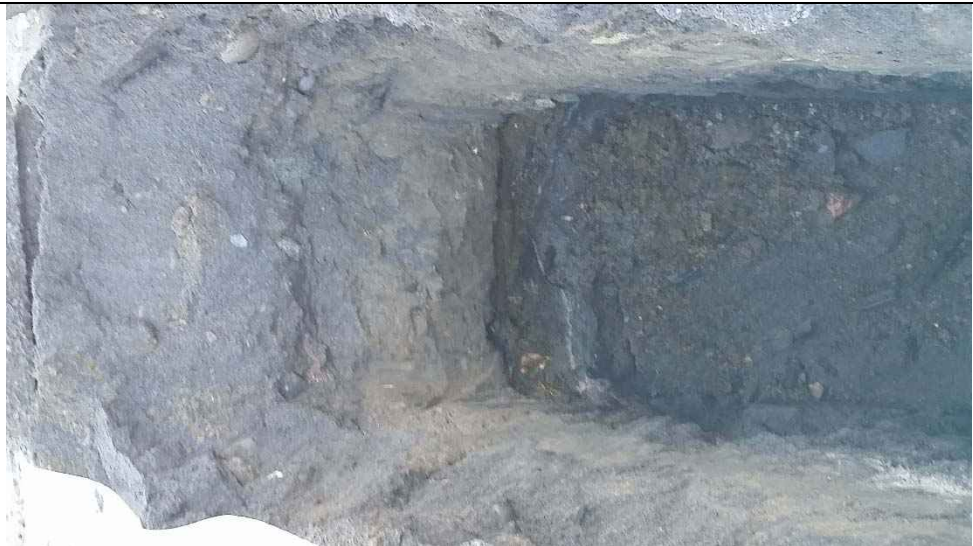
<p>Photograph: 18</p> <p>Description: TP-10 Concrete Stained foundation piece on eastern end of TP</p> <p>Location: Brooklyn, NY</p> <p>Photograph taken by: Kyle Warren</p> <p>Date: 1/19/2017</p>
