March 3, 2017

Re: Former Dangman Park Manufactured Gas Plant Site
IRM Premobilization Investigation Results
Brooklyn, New York
NYSDEC Site No. 224047
Index # A2-0552-0606

IRM PREMobilIZATION INVESTIGATION

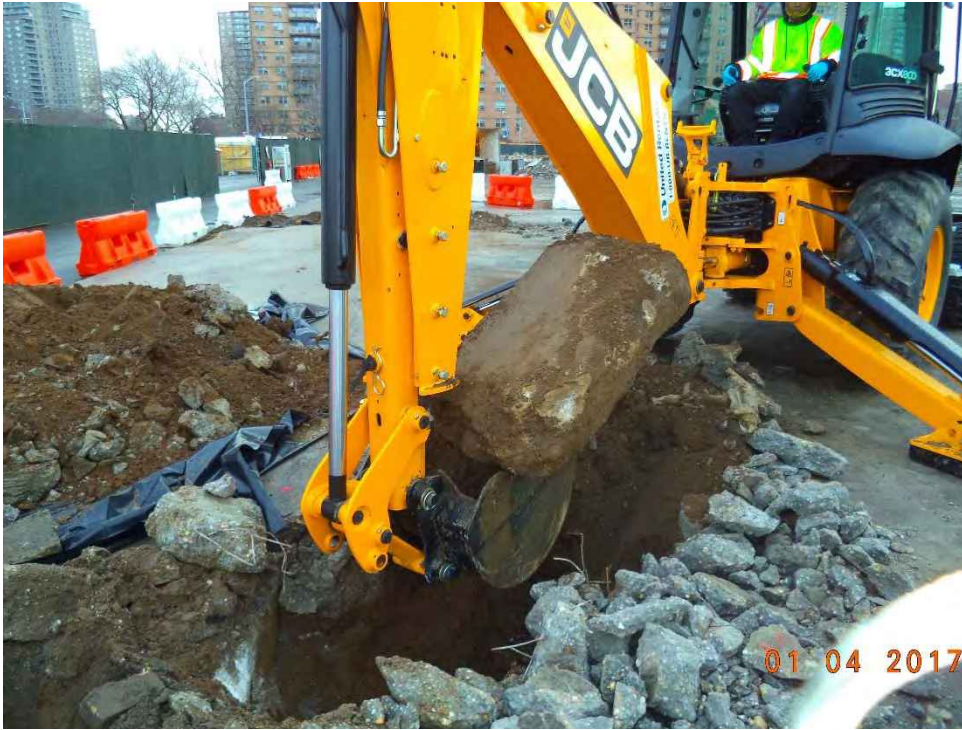
Photograph: 1

Description:
TP-01

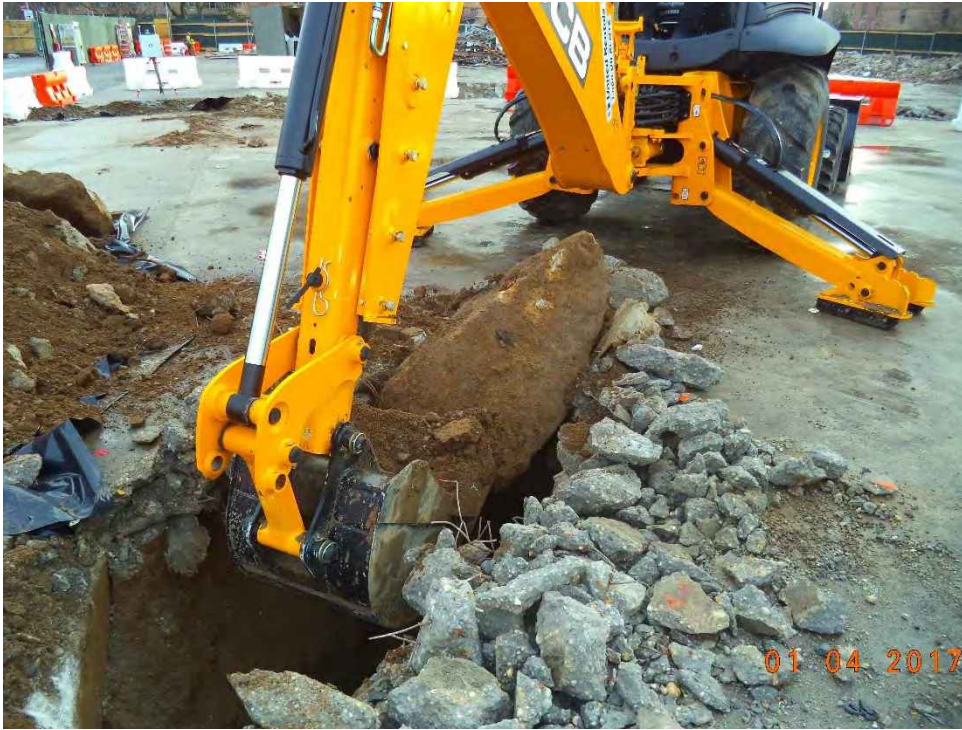
Photograph: 3

Description:
TP-01

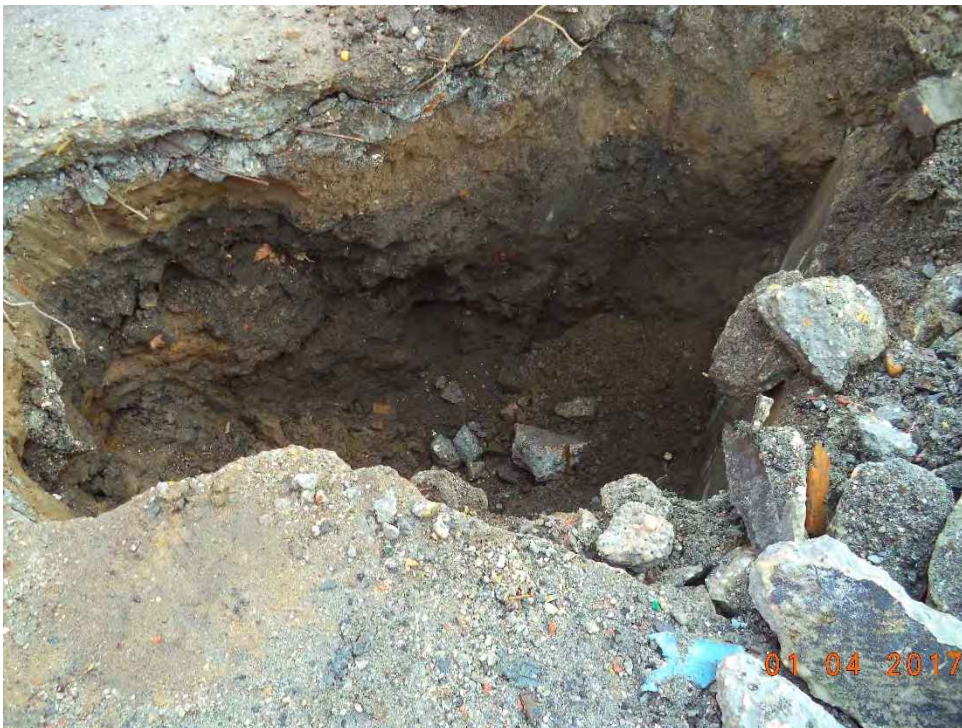
Photograph: 4

Description:
TP-01

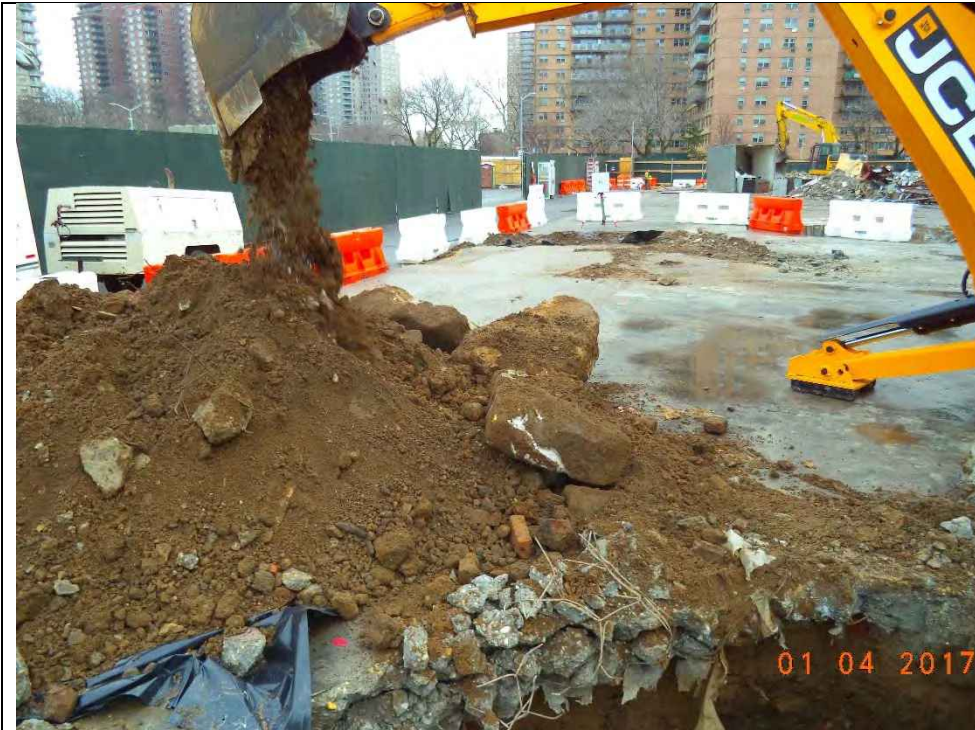
Photograph: 7

Description:
TP-01

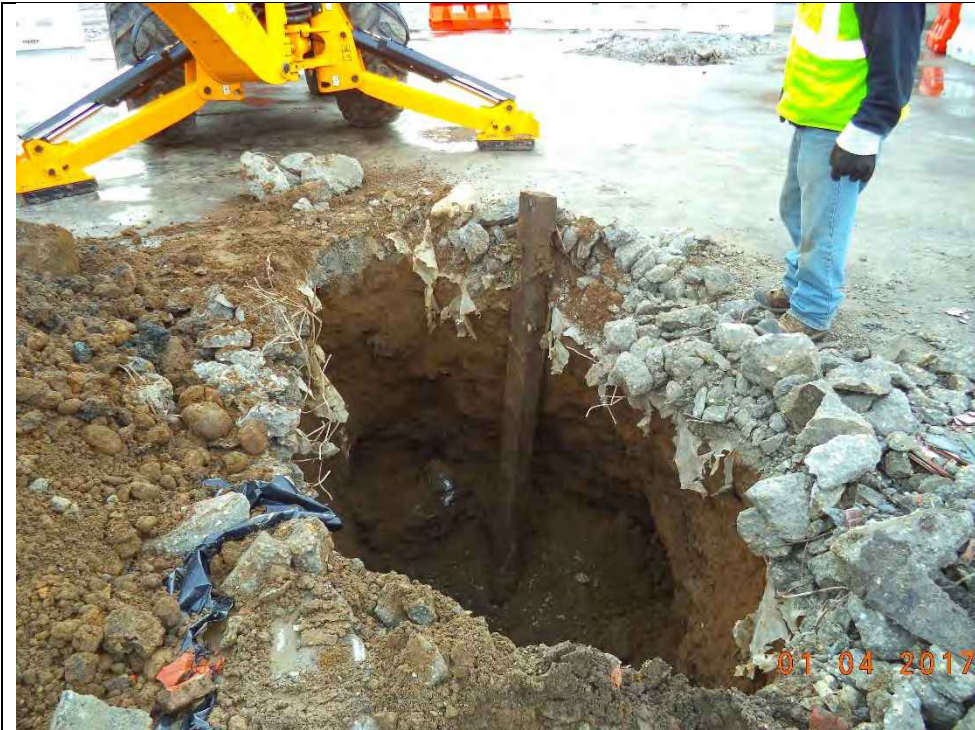
Photograph: 9

Description:
TP-01

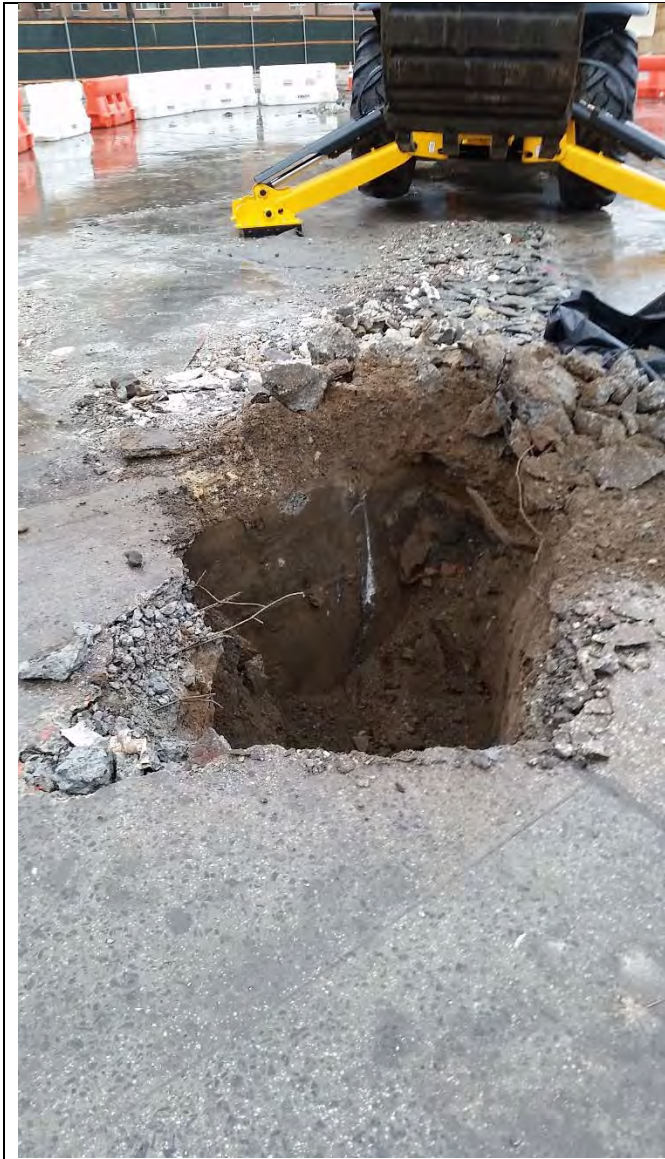
Photograph: 12

Description:
TP-02

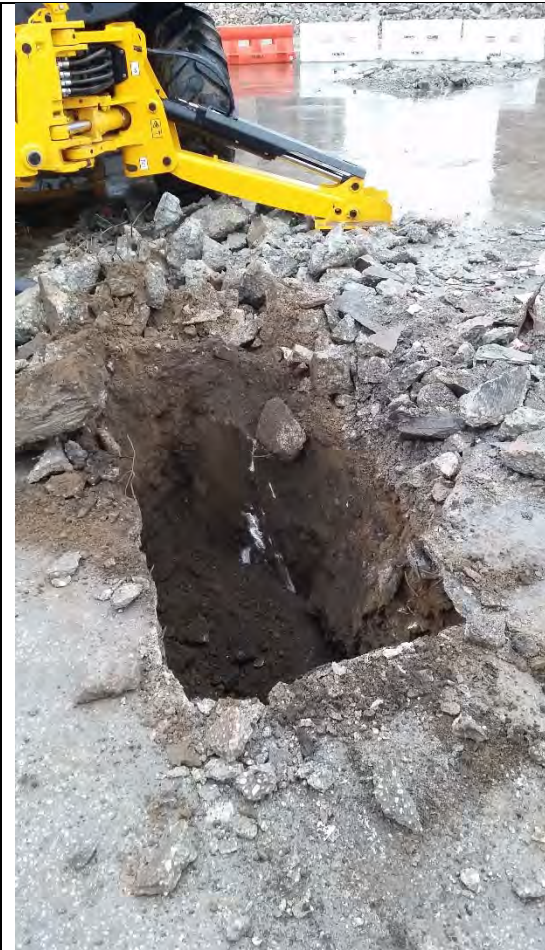
Photograph: 13

Description:
TP-02

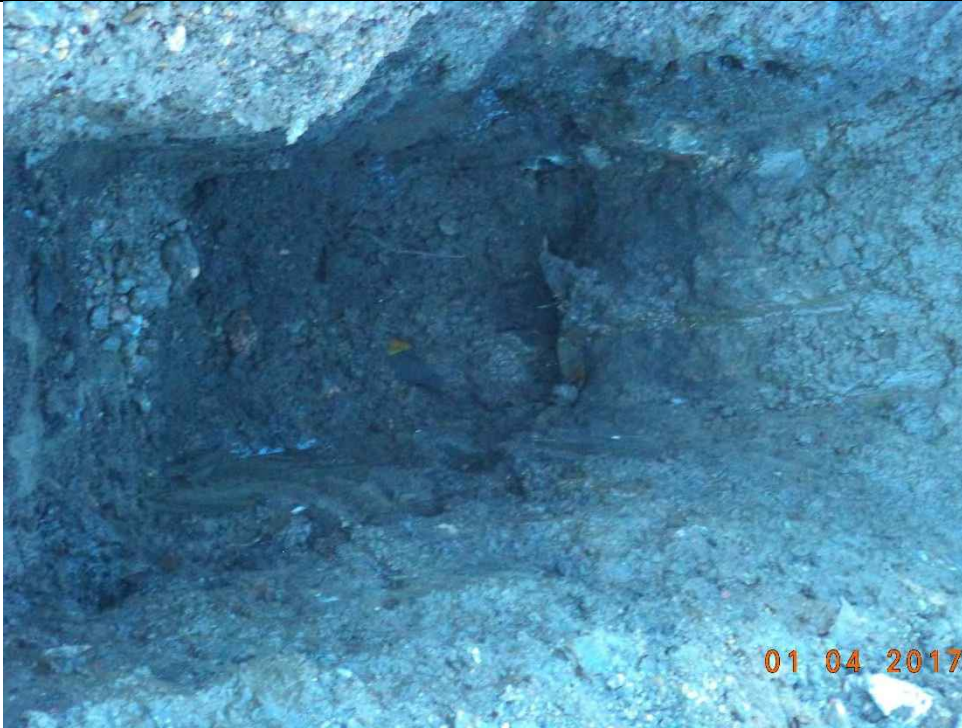
Photograph: 17

Description:
TP-03

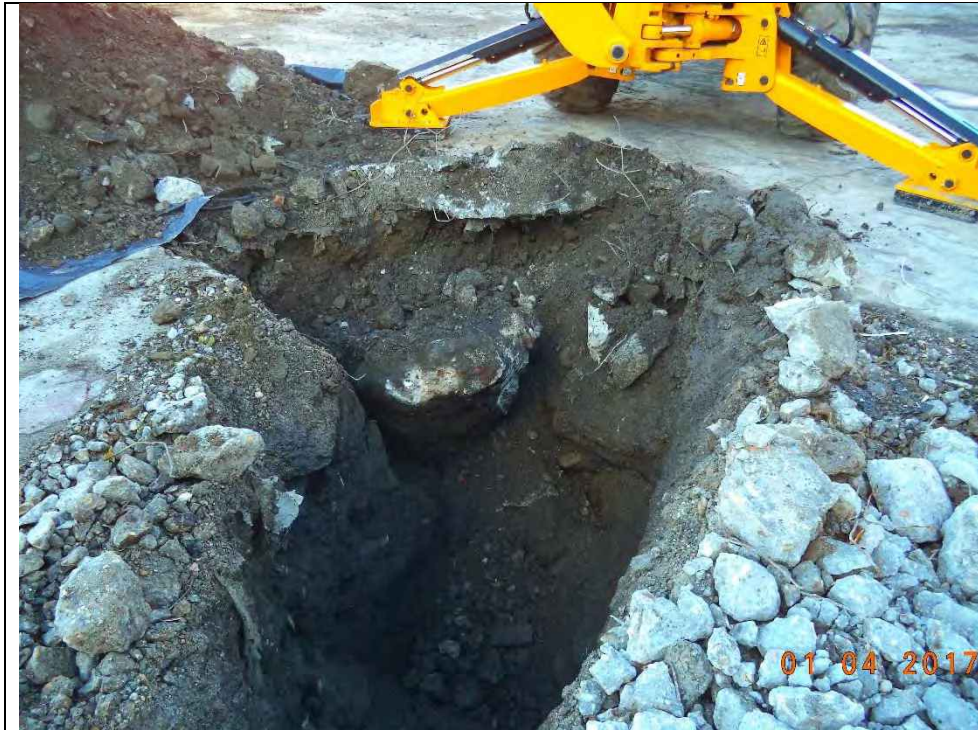
Photograph: 19

Description:
TP-03

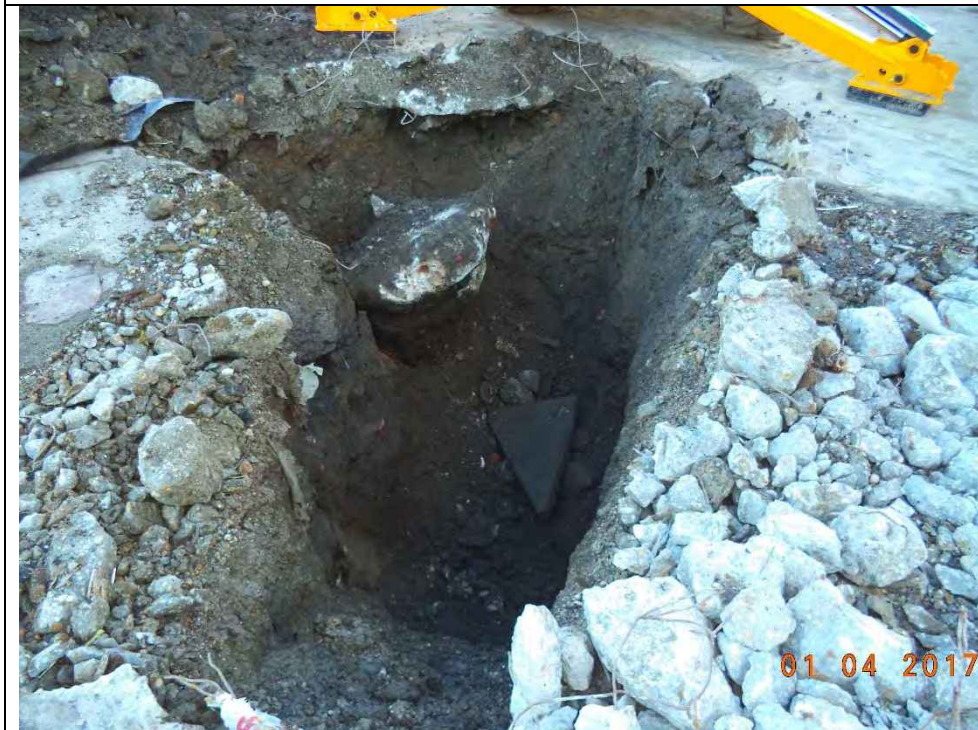
Photograph: 20

Description:
TP-03

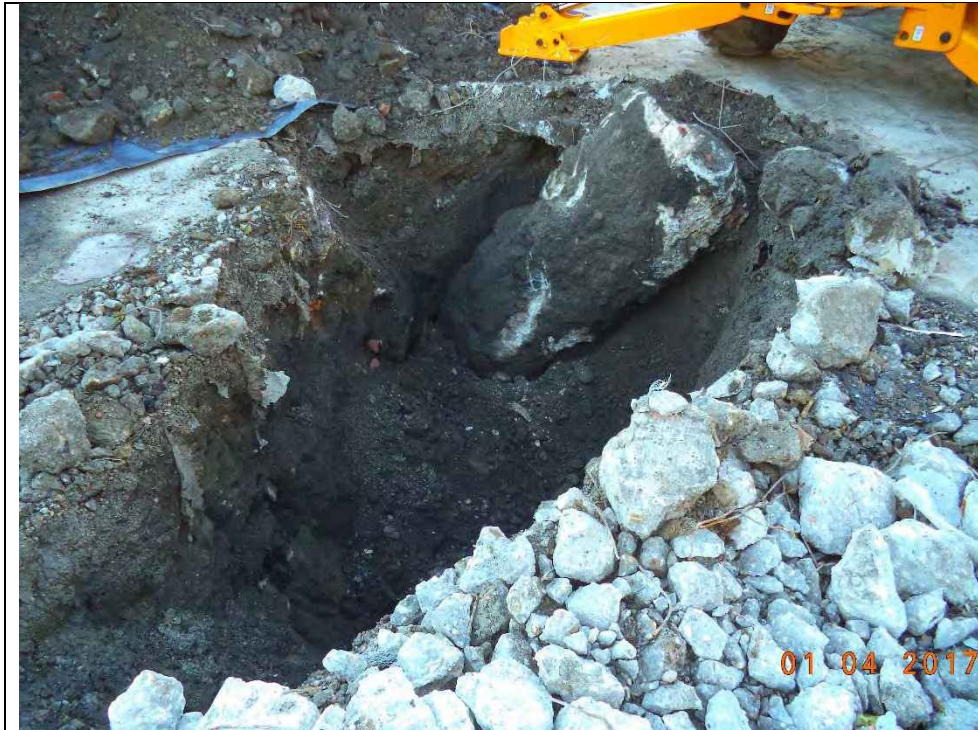
Photograph: 21

Description:
TP-03

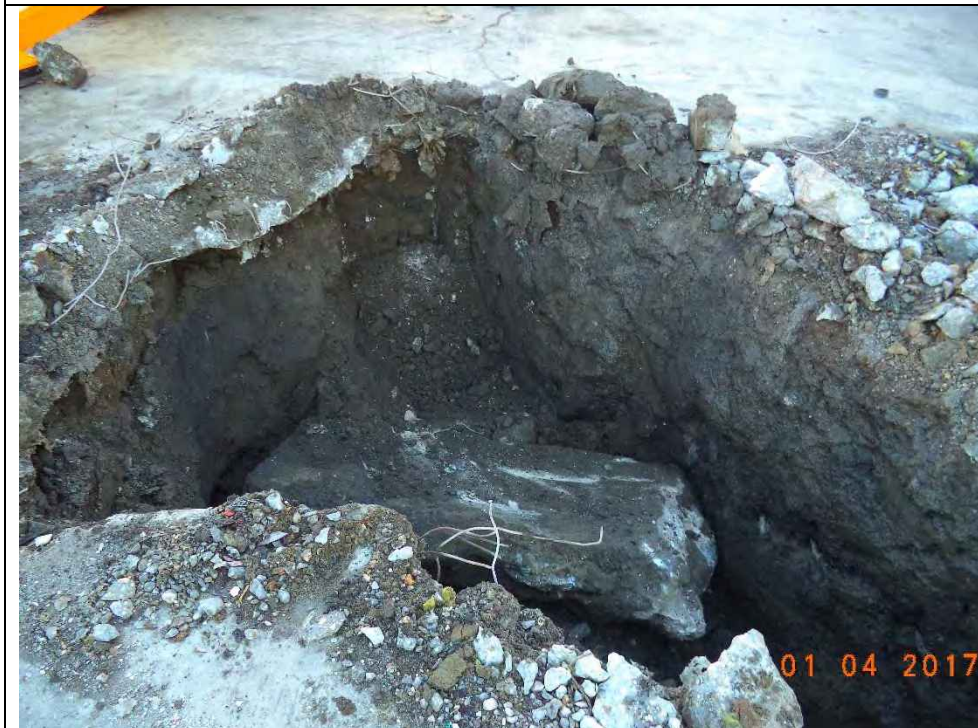
Photograph: 22

Description:
TP-03

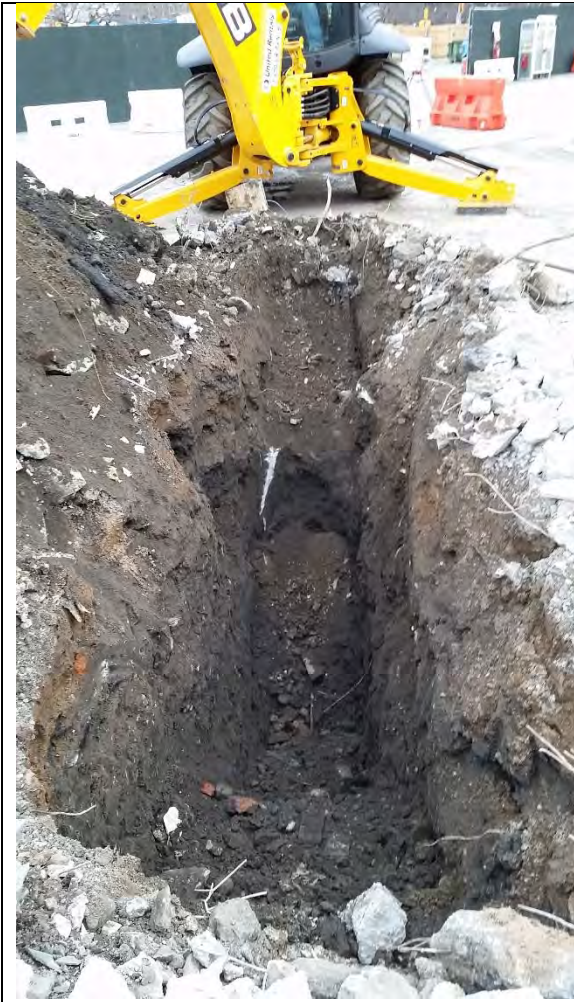
Photograph: 25

Description:
TP-04

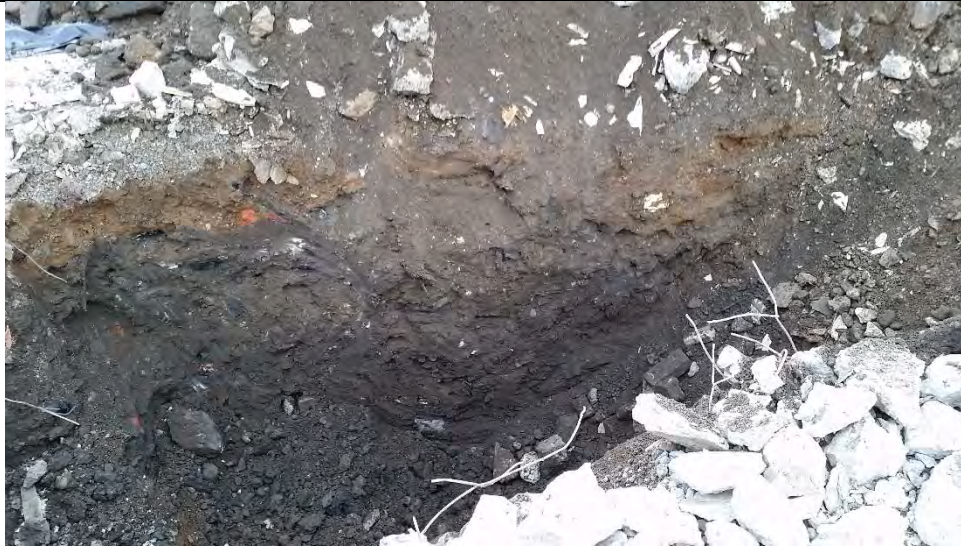
Photograph: 28

Description:
TP-04

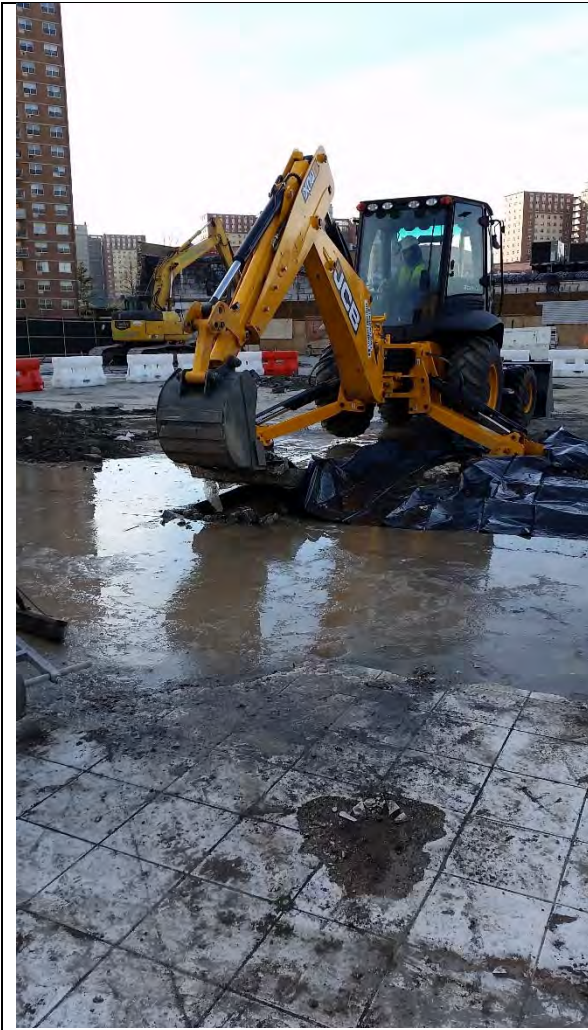
Photograph: 30

Description:
TP-05

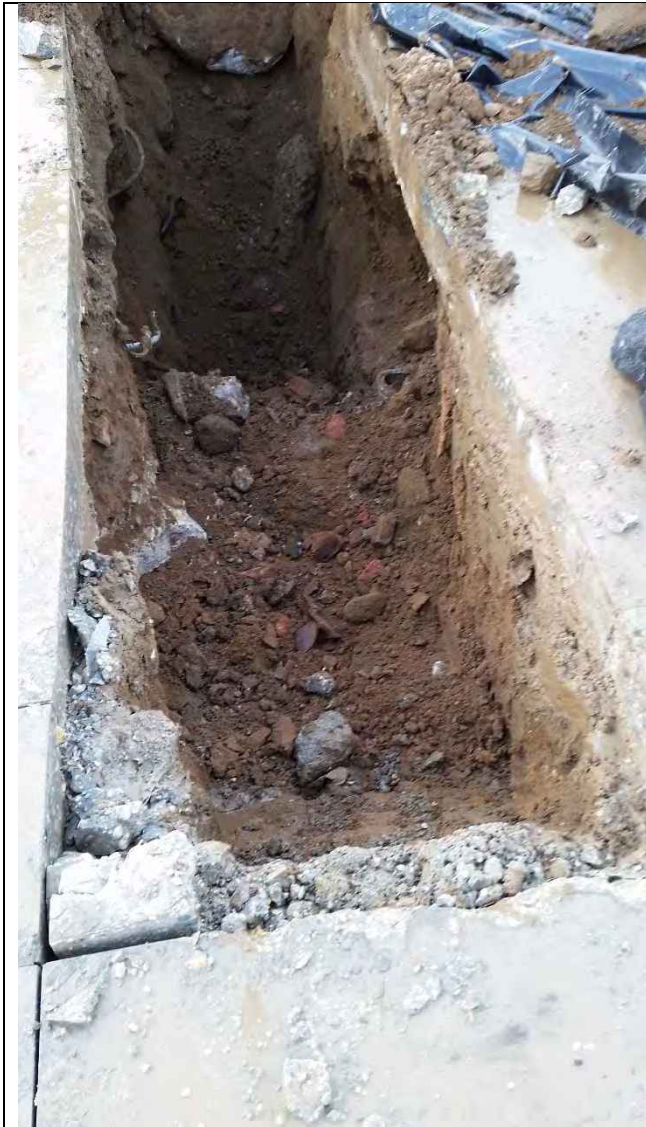
Photograph: 32

Description:
TP-05

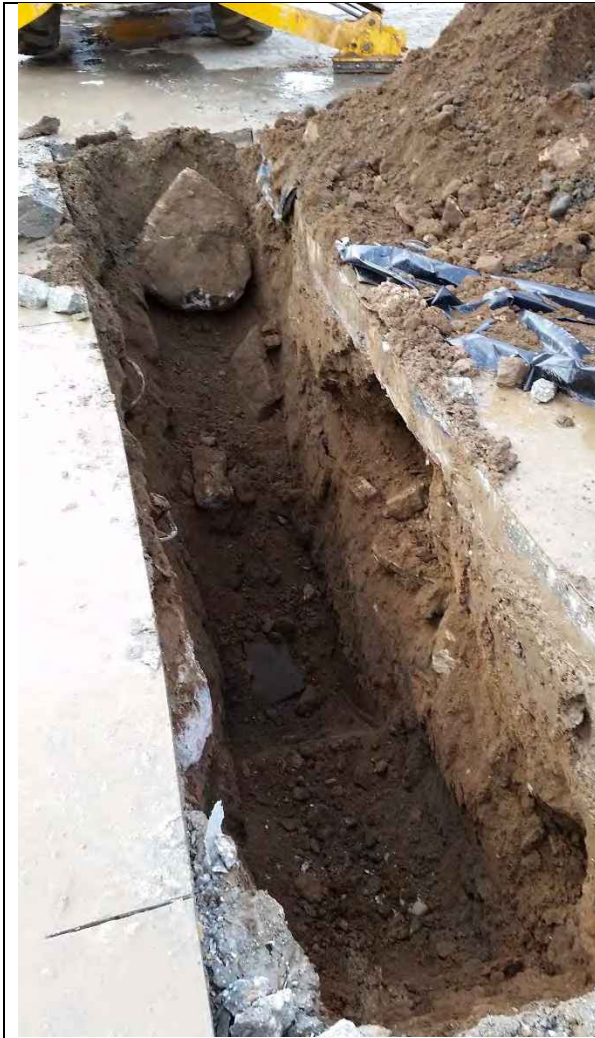
Photograph: 35

Description:
TP-05

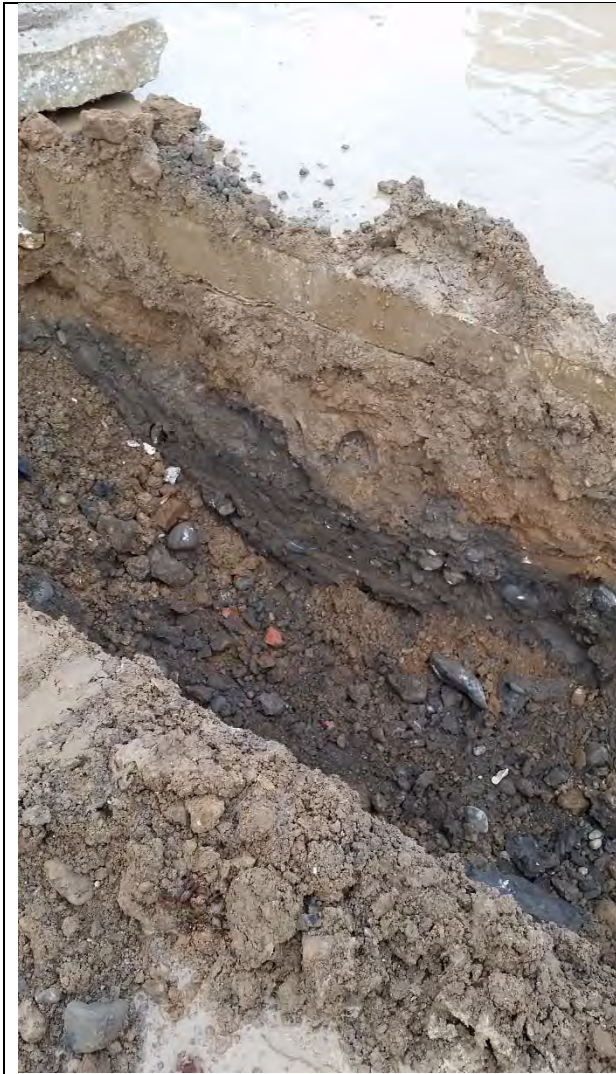
Photograph: 39

Description:
TP-06

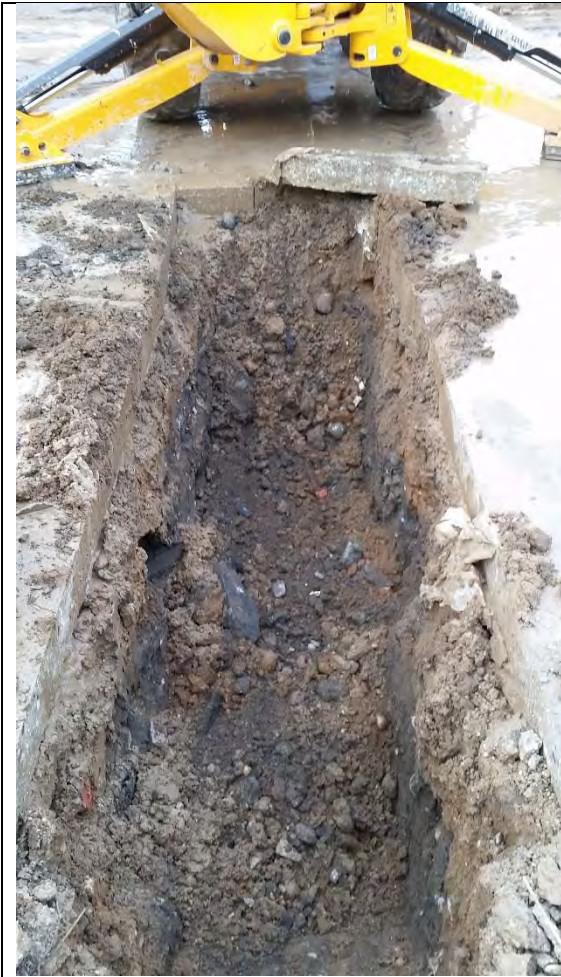
Photograph: 40

Description:
TP-06

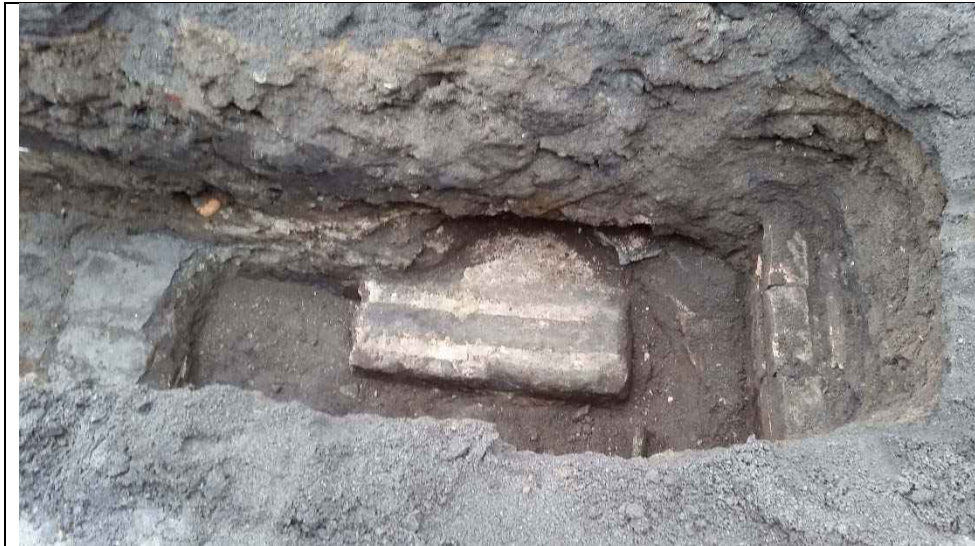
Photograph: 11

TP-09
Brick Wall on Eastern
End (right), concrete
piece in middle,
concrete stained piece
on western end (left)

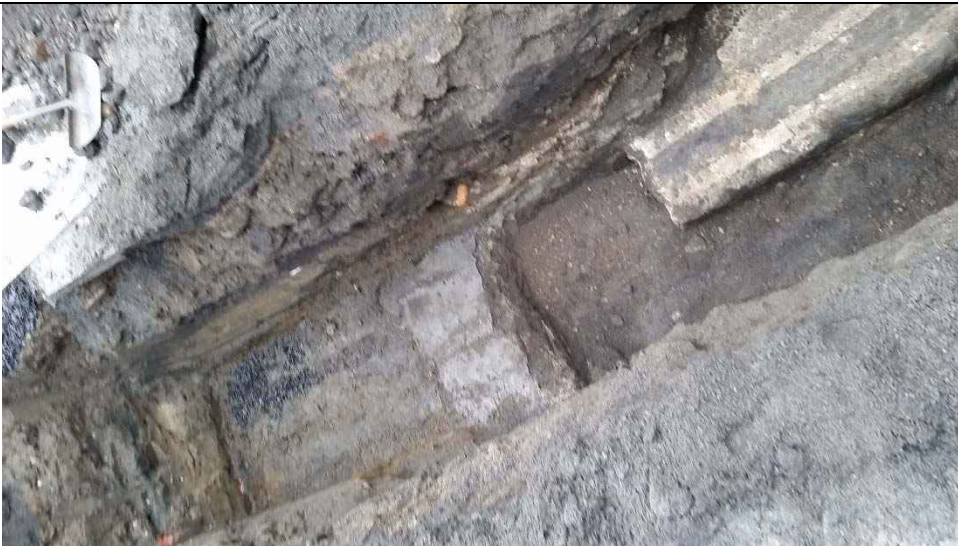
Photograph: 12

TP-09
Concrete stained piece
on western end

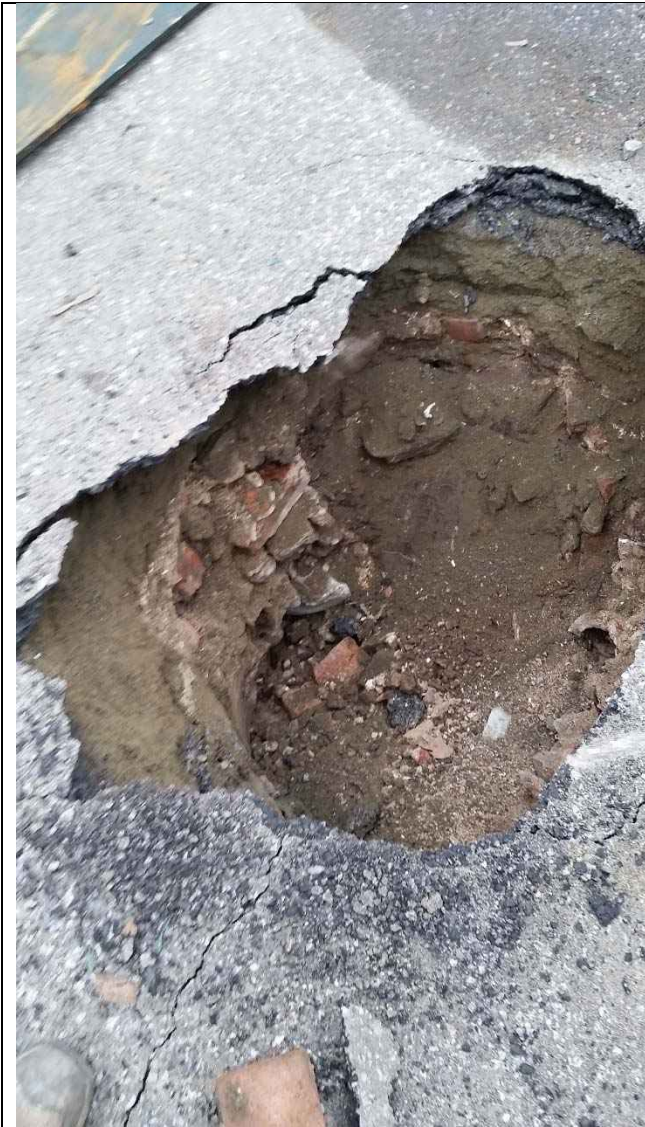
Photograph: 15

15	Fill Materials, heavy brick fill area
16	Concrete stained foundation piece on western end
17	Concrete stained foundation pieces looking east
18	Concrete stained foundation piece on eastern end

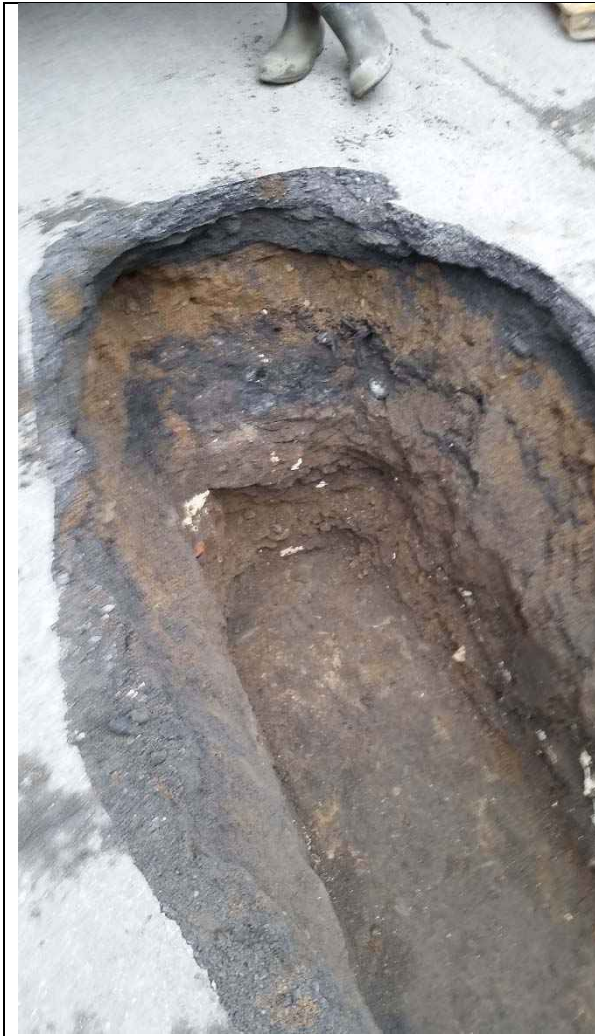
Photograph: 19

19/20	Concrete stained foundation along entire bottom
21/22	Fill Materials

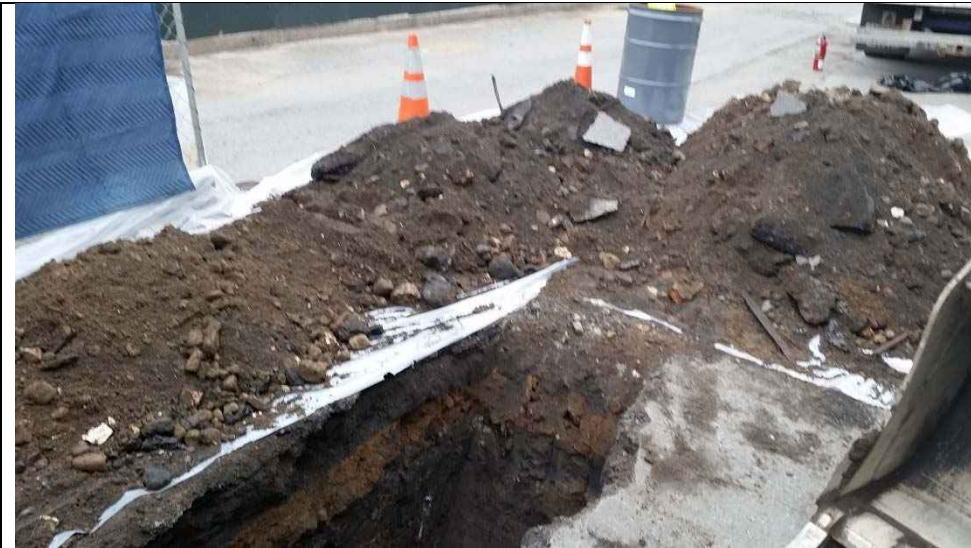
Photograph: 21

Description:
TP-11
Fill Materials

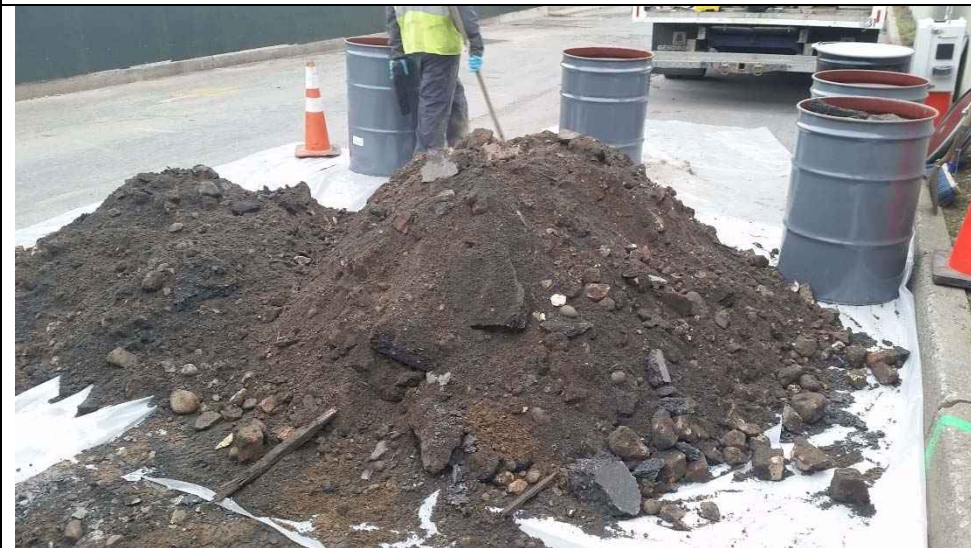
Photograph: 22

Description:
TP-11
Fill Materials
